# A Method for Developing Regional Road-Fill Failure Hazard Assessments Using GIS and Virtual Fieldwork

**Key Terms:** *Models, Probability, Landslides, Management, Geomorphology, GIS*

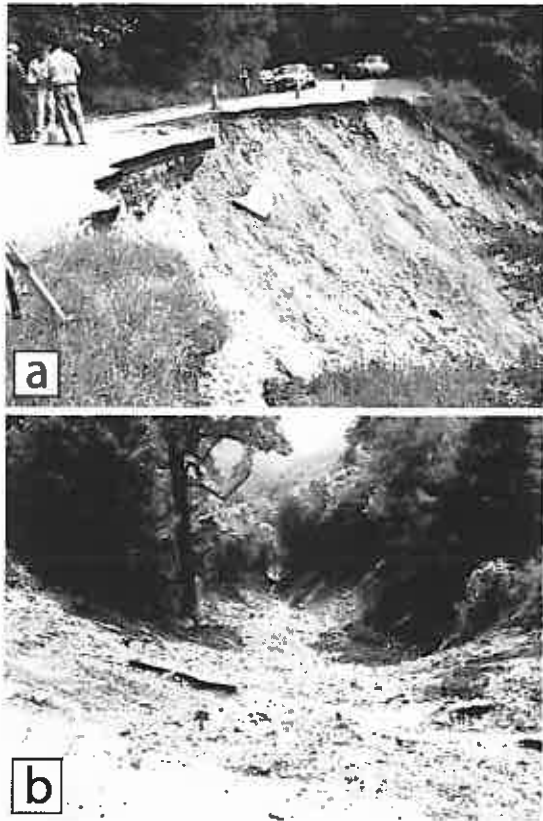
Figure 2. (a) Initiation site of road-fill failure (milepost 348.8) and (b) downslope impacts from debris flow. Arc-shaped pavement crack at initiation site was evident months prior to failure in September 2004. Photos courtesy of the Federal Highway Administration.

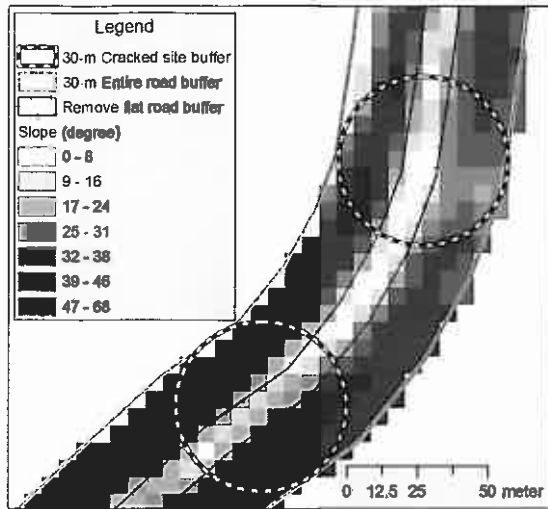
Figure 4. Figure shows segment of slope raster output from Geographic Information System (GIS). Analysis buffers with 30-m radius to extract slope distributions are shown as bold, dashed lines for failed-or-cracked sites and as a gray line for the entire uncracked road. Hatched lines are 6-m-radius analysis buffers used to remove slope distribution of flat, paved road.

To characterize the slope distribution representative of the failed-or-cracked sites, we extracted slopes from 30-m-radius circular buffers centered on the surveyed location of the cracks for each of the 21 failed-or-cracked sites. Each circular buffer contains ~70 cells. As illustrated in Figure 4, we used a 6-m-

radius buffer through each site to extract the slope values associated with the paved roadway (~18 cells per site) and then subtracted these values from the failed-or-cracked slope distributions for each site. Figure 6 shows the distributions of all slope values for all 21 sites lumped together, with and without the paved roadway data. Finally, to fully separate the failed-or-cracked and uncracked slope distributions, we subtracted the lumped failed-or-cracked slope values from the entire roadway slope set to obtain two distributions representative of the two distinct site populations, shown in Figure 7.

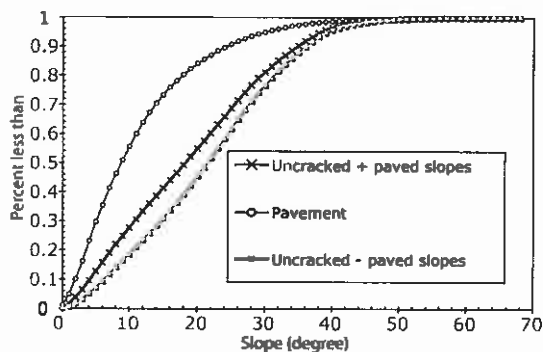
Figure 5. Plot shows a cumulative, normalized distribution of cracked slopes plus paved slopes from entire roadway in study area. Paved slopes and cracked minus paved slopes are also shown.

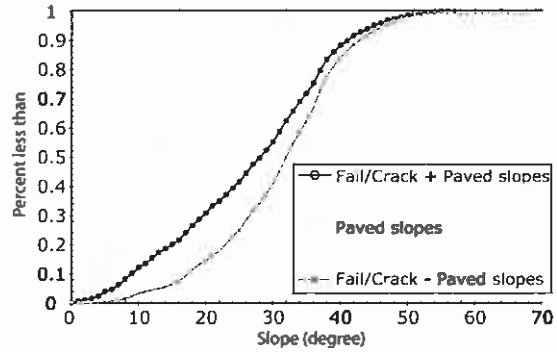
Figure 6. Plot shows a cumulative, normalized distribution of lumped failed-or-cracked slopes plus paved slopes from individual sites in study area. Paved slopes and failed-or-cracked minus paved slopes are also shown.

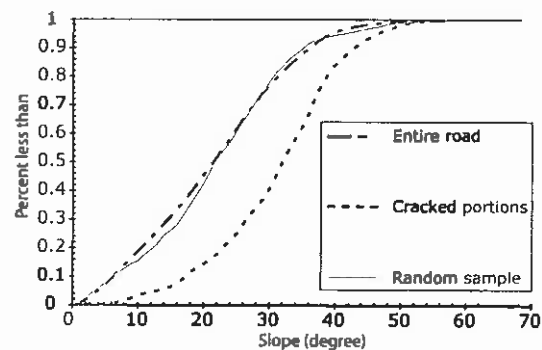
Figure 7. Plot shows a cumulative, normalized distribution of lumped failed-or-cracked slopes and the entire uncracked road. The distribution of 21 randomly selected, uncracked sites shows good agreement with the entire uncracked population.

Like the lumped slope distributions in Figure 7, there is a clear difference in the site-median slopes between the failed-or-cracked and uncracked portions of the roadway. A *t*-test shows that the difference of 9.7° between the means of the site-median slopes is significant at a confidence level of 99 percent ( $P < 0.01$ ; Table 1). We used the statistics of the site-median slope distributions to develop a model for evaluating the likelihood that any given currently uncracked site may be topographically more consis-

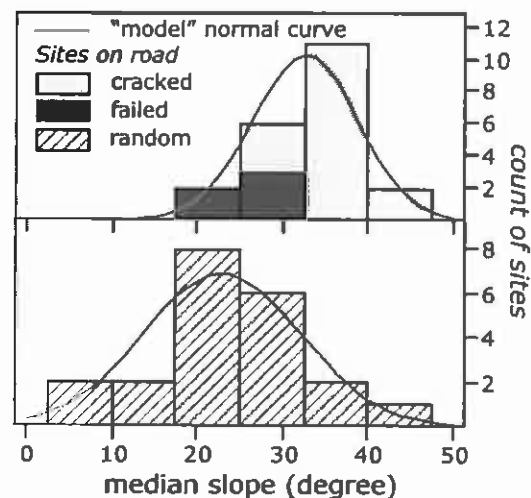
Figure 8. Frequency distribution plots of median slope from individual failed ( $N = 6$ ) and cracked ( $N = 15$ ) and randomly selected uncracked sites ( $N = 21$ ). Model Gaussian (normal) curves are fitted to these distributions.

slope from each slope distribution. The distributions of site-median slope for failed-or-cracked and uncracked sites are shown in Figure 8. Also shown are curves representing normal (Gaussian) probability density functions of site-median slope,  $p(S)$ , given by

where  $\mu$  and  $\sigma$  are the mean and standard deviation of the measured distributions, respectively. Figure 8 indicates that the distribution of possible site-median slopes can be treated as normally distributed, as predicted by the central limit theorem.

The result that the lowest median slope values came from the failed sites was not expected (Figure 8). However, the proximity of these locations to the highest elevations and steepest slopes of Mount Mitchell indicates that rainfall intensity and duration were greater as a result of orographic forcing. This is not necessarily inconsistent with the site-median slope method, because we assume that potentially unstable sites become unstable when rainfall sufficient to initiate landsliding reaches the road fill.

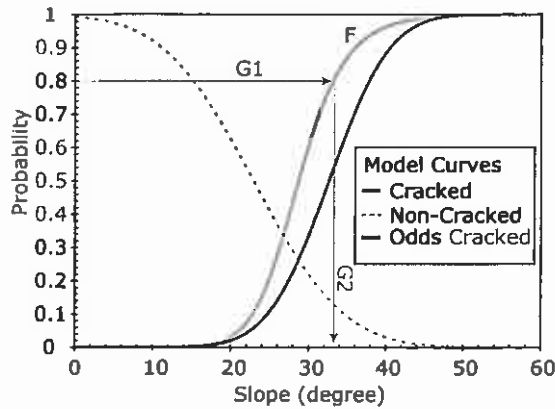
Figure 9. Diagram shows decision-making model used for determining the level of confidence (G1) and median slope, failure criterion (G2) associated with road-fill failure hazards. Curves are shown as cumulative, normalized distributions. See text for further explanation.

Figure 9 shows the cumulative distribution,  $P_c(S)$ , for the normal fit to the failed-or-cracked site-median slopes, given by

which describes the probability that any location that belongs to the population of potentially unstable sites will have a median slope less than or equal to  $S$ . Also plotted in Figure 9 is the complementary cumulative distribution,  $P_u^*(S) = 1 - P_u(S)$ , which describes the probability that a site will have a median slope greater than or equal to  $S$  if it belongs to the stable, uncracked site population. (Note that the subscripts "c" and "u" refer to the failed-or-cracked and uncracked distributions, respectively; the superscripted asterisk indicates the complementary cumulative distribution.) Figure 9 shows that as site-median slope increases, the value of  $P_u^*(S)$  declines and the value of  $P_c(S)$  increases, because steeper slopes are more likely to be unstable. Note that the two curves cross where the median slope equals  $\sim 29^\circ$ .

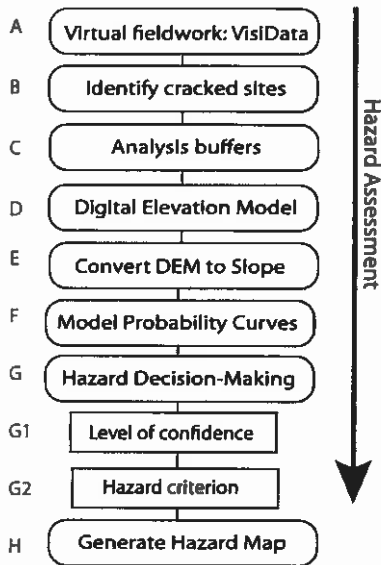
Figure 10. Conceptual model of hazard assessment using median-slope method and probabilistic assessment.

Application of the decision model is illustrated in the following example, in which a confidence level of 80 percent has been selected. Figure 10 shows a conceptual model of the median-slope method and probabilistic hazard assessment. Figure 9 shows the analytical pathway (labeled G1) from the probability axis to the odds curve (labeled F) and the pathway (labeled G2) to the corresponding median-site slope above which sites would be considered potentially unstable, which here equals  $33^\circ$ . With 80 percent confidence, sites with median slopes steeper than  $33^\circ$  could be classified as potentially unstable, even though no pavement crack-
